Improving Thermal Efficiency: Historic Wooden Windows

**The Colcord Building
Oklahoma City, Oklahoma**

Sharon C. Park AIA

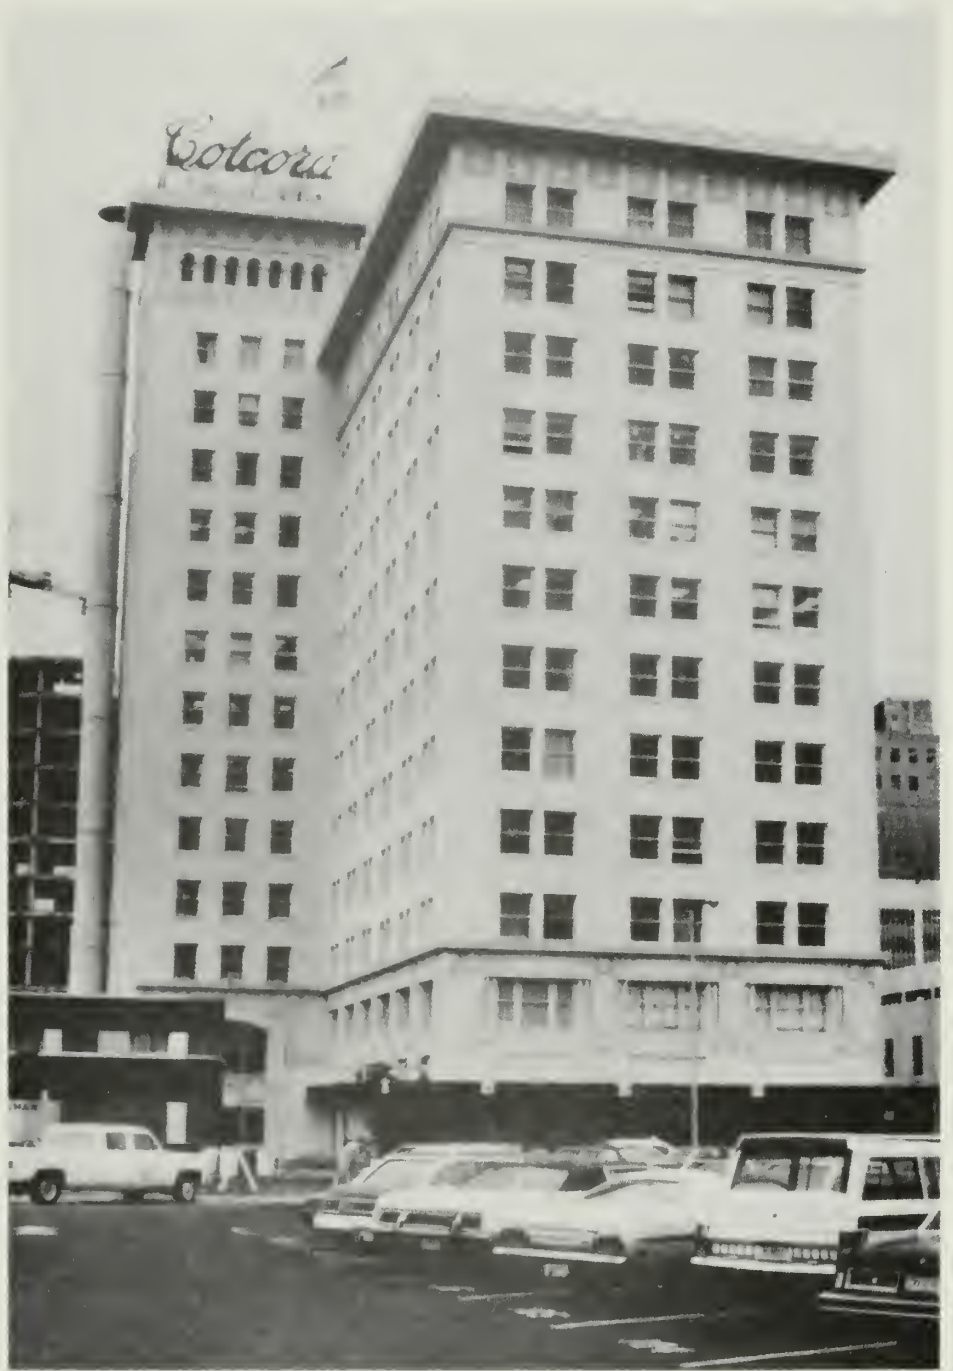
Figure 1. *The Colcord Building, Oklahoma City, Oklahoma. This 12-story poured-in-place concrete building with terra-cotta ornamentation was built in 1910 and is individually listed on the National Register of Historic Places. (Photo: H. Ward Jandl)*

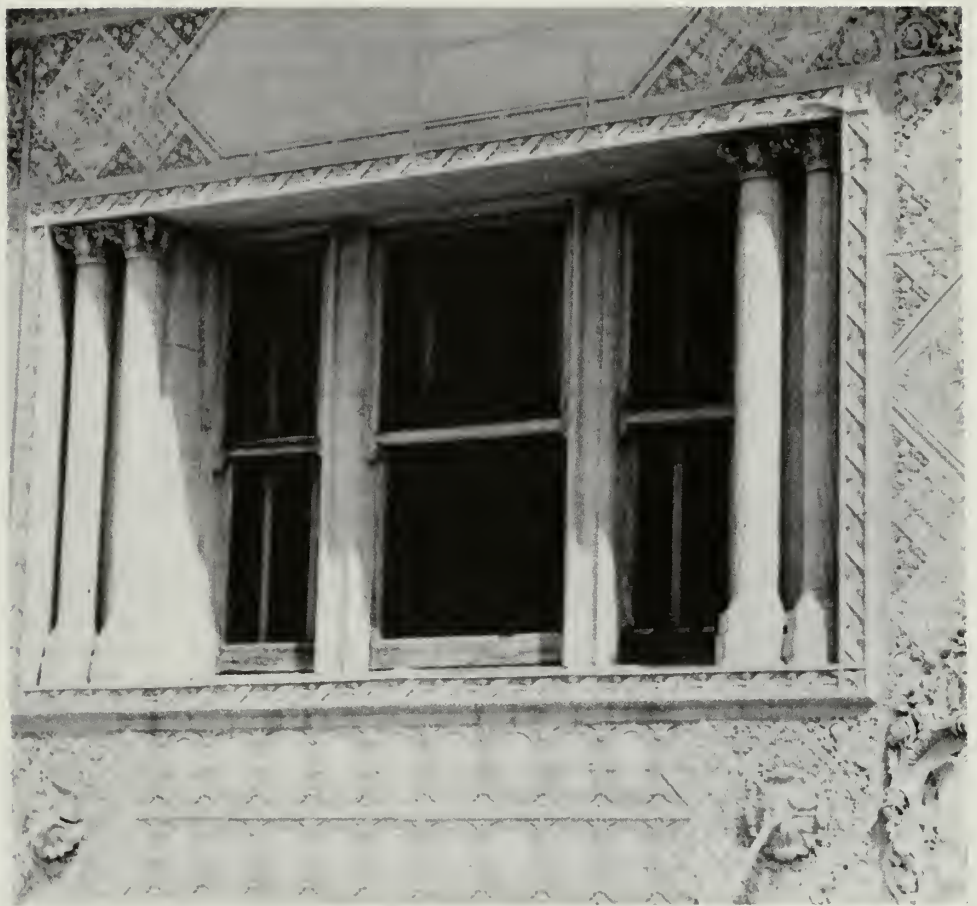
Figure 2. Original second-floor wooden windows of the Colcord Building. Note the high degree of ornamentation with the composition of the triple windows, the deep setbacks, the paired Corinthian columns, and the Sullivanesque terra-cotta panels surrounding the windows. The windows on the upper floors are of a simpler composition being paired one-over-one double-hung windows. (Photo: Jack Graves, AIA)

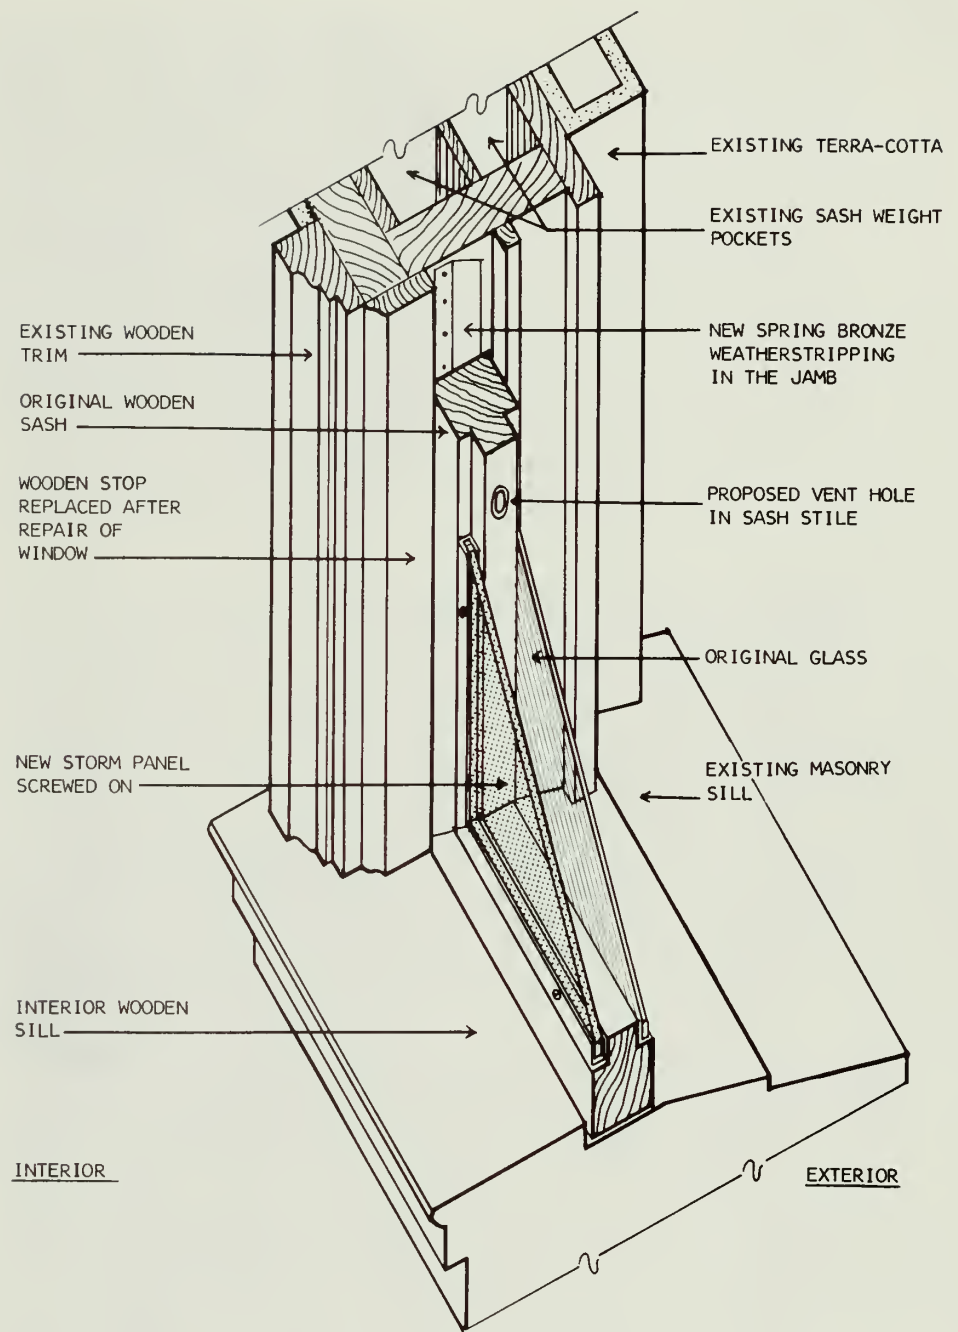
The architect's two concerns were the routing, or rabbeting, of the windows' wooden rails and stiles and the impact the additional weight of the storm panels would have on operating the windows. The cross-section of the sash rails and stiles was 1 7/8 by 2 inches of solid wood in good condition. The proposed rabbet of 1/2 by 3/8 inch was, therefore, not substantial enough to weaken the windows. This rabbeting would still allow a thermal cavity of a full inch between the glazing layers. The second concern was whether the existing sash weights could tolerate the additional weight of the storm panels. The Colcord Building windows vary from 22 by 66 inches to 48 by 66 inches and are composed of an upper and lower sash. The corresponding weight of the storm panels was approximately 3 to 8 pounds. The architect determined that the existing sash weights were adequate and specified that the pulleys of the sash chains be lubricated during the retrofitting to ease operating the heavier windows. (see figure 3)

Figure 3. Cutaway view of the window showing the proposed interior storm panel in place. Note the new weather stripping on the frame of the window and the proposed vent hole on the wooden sash stile.

moist air from penetrating into the cavity between the two layers of glazing. The vent holes, drilled laterally through the sash stiles, were to provide a minimum amount of circulation within the cavity to reduce condensation.(see figure 3)

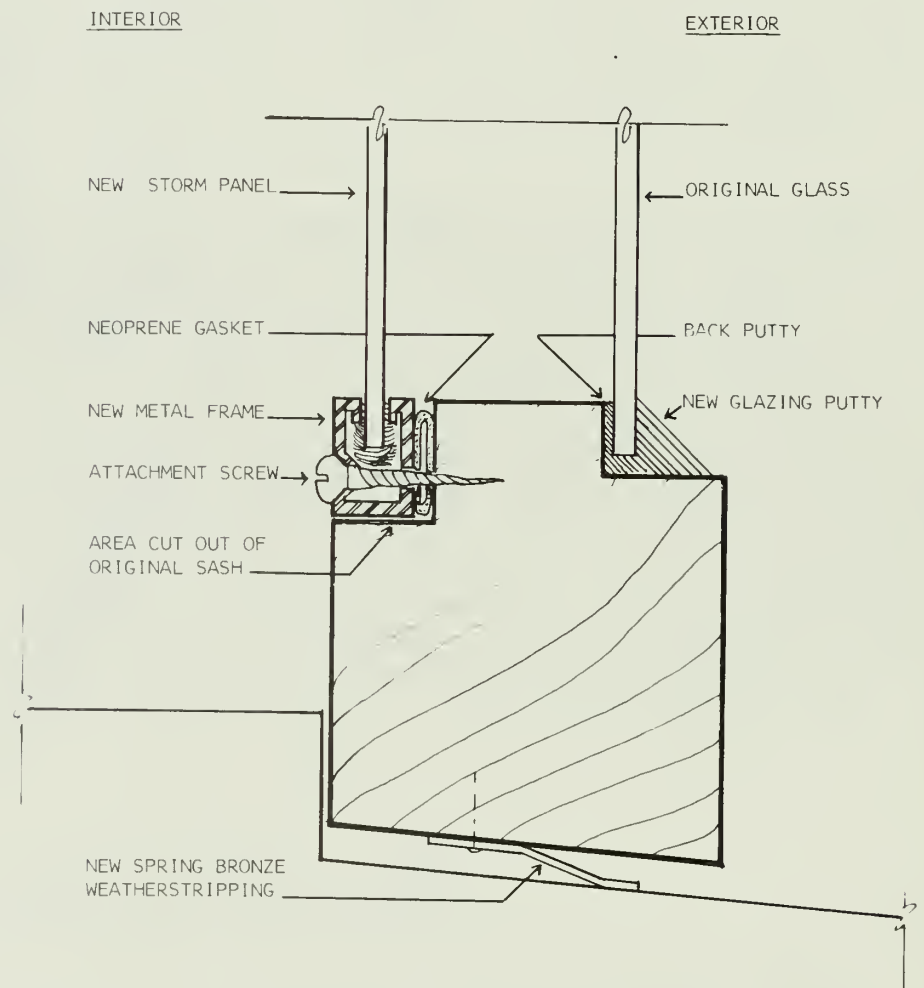
Figure 4. Detailed section through the wooden sash rail with storm panel in place. Note the small area of wood cut out to recess the new storm panel. The cavity left between the two glazing layers is 1 inch which is within the optimum range on $\frac{1}{4}$ inch to $1\frac{1}{4}$ inch for insulated glazing. Note the neoprene gasket that acts to seal out moist air between the storm panel and the wooden window.

Each window sash was taken, in turn, to the workbench where it was prepared for the new storm panel. The glass was carefully removed and set aside. Then a 1/2 by 3/8 inch rabbet was cut from the inside surface of the wooden sash to receive the recessed storm panel (see figures 3 and 4). The loose paint and any remaining dry glazing putty was scraped and removed from the sash. The glass was then reinstalled with a modern glazing compound and a new piece of spring metal weatherstripping was applied to the underside of the lower sash rail before it was returned to its frame (see figure 5). The original window sash were equipped with sash locks at the head and sill, and the architect determined that these locks should be kept fastened at all times to insure that the windows would remain tight in their frames.

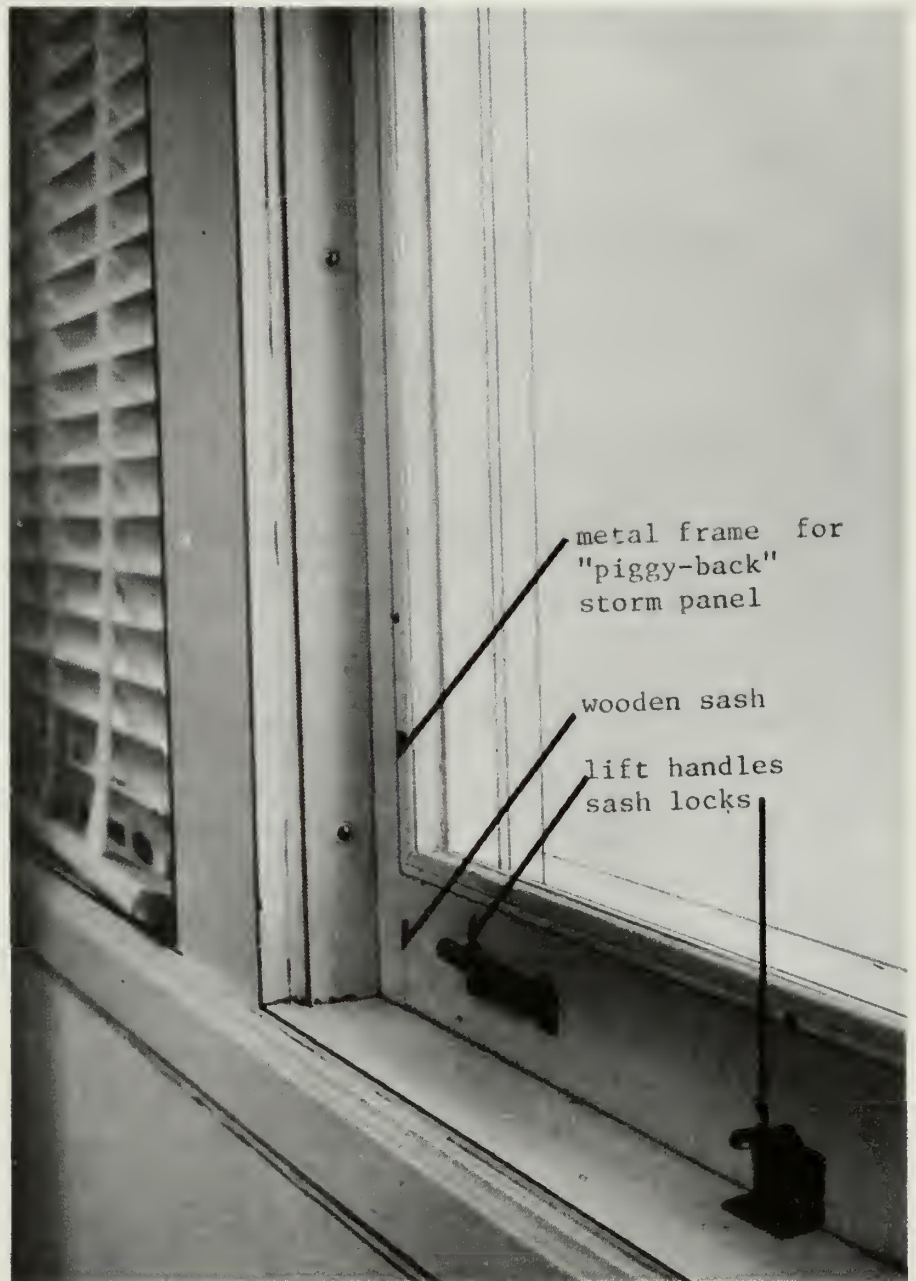
Figure 6. New interior storm panel in place. Note that the storm panel was recessed into the wooden sash. This allows full operability of the window as the lower sash is raised without hinderance from the storm panel on the upper sash. The interior storm panels were affixed with screws and will be removed only for maintenance. (Photo: Tamara Coombs)

The storm panels were installed by the crew floor by floor. The routed openings of the sash were measured and then float glass was cut in a basement workshop. Sections of extruded metal with an enamel coating were cut to the appropriate length and affixed to the glass with a hand crimping tool. The storm panels were then screwed into place (see figure 6). Because the storm panels were fabricated on the site, there was no need to keep a complicated inventory of window sizes, location, and so forth. There were also none of the problems associated with the transport and storage of such a large order.
